Maindee Community Street Audit

A Community Street Audit
Maindee, Newport

Commissioned by Newport City Council

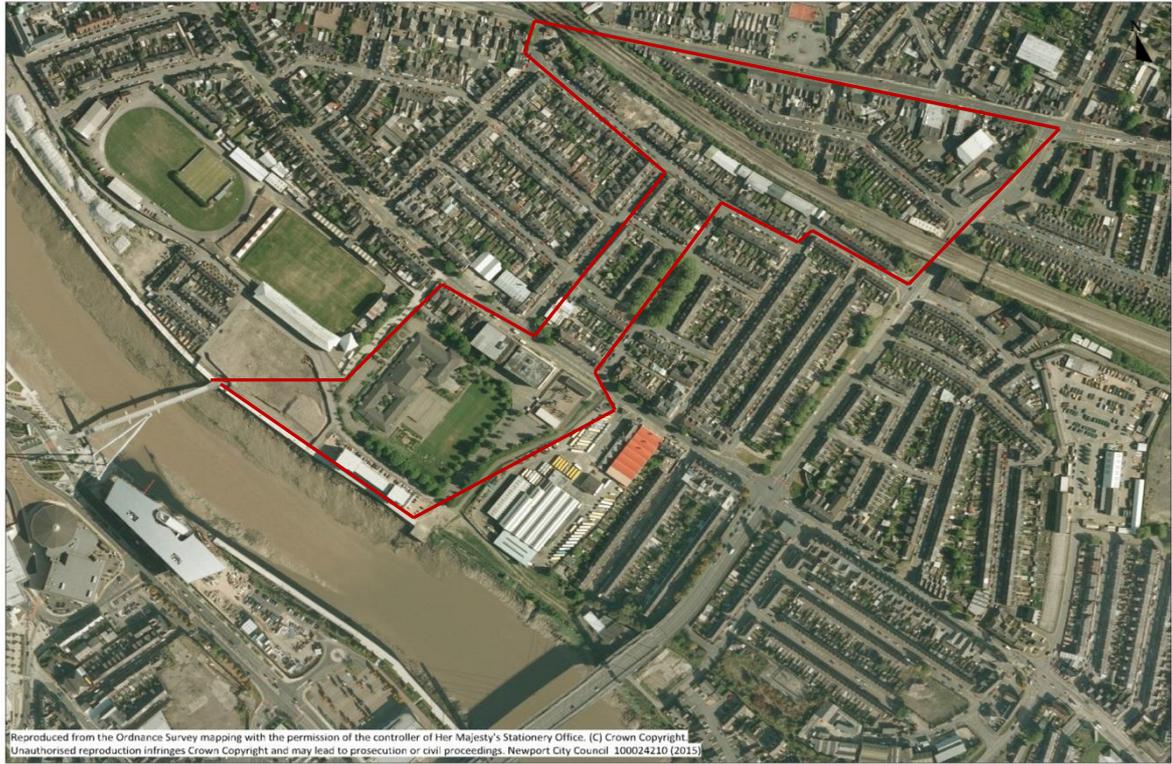
Audit Route

The audit started and finished at Community House on Eton road in the heart of the Maindee neighbourhood. It then proceeded from Eton road onto Marlborough road, Harrow road and then on to the B4237 Chepstow road. The route then turned onto Wharf road and then into Jeffrey Street, Oriel road and Malvern road. Crossing Corporation Street, the route then took the walkway to the riverside before returning to Eton road via the walkway in front of the school.

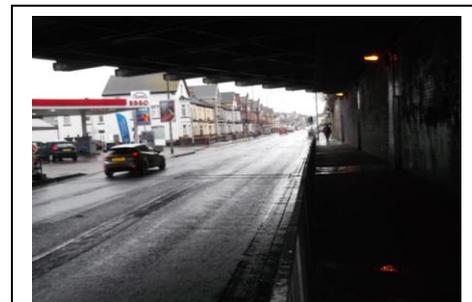
Poor lighting and noise are the key features walking under the train bridge

Specifically, walking under the bridge is a noisy experience. The lighting is poor. The street audit was conducted in the middle of the day but there was very little natural light underneath the bridge and the existing lights were not bright enough. The guttering was dripping due to the rain and the brick sidewall was in need of industrial clean.

The brick sidewalls under the bridge could be coloured by local art, as a means to revitalise this key gateway into Maindee.

No.	Location	Issue	Recommendation	Timescale
1	Chepstow Road Train Bridge	Poor maintenance	Liaising with maintenance contractor to ensure regular cleaning and maintenance of guttering and brick work	Short term
1	Chepstow Road Train Bridge	Poor appearance and lighting	Liaising with relevant authority to improve lighting as well as exploring options on devising a community mural project to brighten the space	Short term
2	Public realm land and toilet block on Chepstow Road	Poor use of public realm space	Exploring ownership of toilet block to then begin devising plans for a redesign of existing space	Medium term
3	Probert Place cut through between Livingstone Place/Glebe Street and Chepstow Road	Poor pedestrian safety with no footways and poor visibility	Liaising with Newport City Council Transportation to assess viability of the cut through become adopted to improve safety	Long term
4	Junction of Chepstow Road and Albert Avenue	Poor junction design providing unnecessary obstacle for people moving in retail centre	Liaising with Newport City Council Transportation to propose new capital works to improve the design and balance of this junction as a means to improve safety	Long term

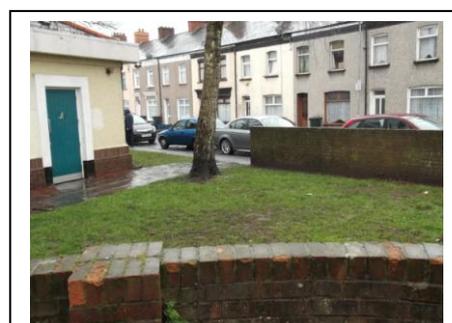
From the train bridge, the street audit moved East down Chepstow Road. The group then encountered a small area of public realm and a toilet block opposite the Library. Currently, there is a triangular piece of land set back from the footway with some grass, bushes and a series of brick walls. This is adjacent to a toilet block that is in a poor state of repair. The public realm land and the toilet block hold a significant location opposite the Library and on the edge of Maindee's main retail thoroughfare.

Poorly used public realm land adjacent to public toilet block

As a result of this, there is a significant opportunity to make better use of this land as a means to regenerate Maindee's retail centre into a vibrant place to visit. It seems that there may be two options to explore here. To start with, a redesign of the existing public realm space would provide a more attractive space for local people. If it transpired that the public toilets were no longer needed, there would then be the opportunity of remove the block providing a sizeable plot of public realm land. Maindee,

as a neighbourhood, has a very low amount of green space. Green space is essential to enable residents to live more healthy lives. It would be prudent to consult with the local community in developing designs for this new public realm space.

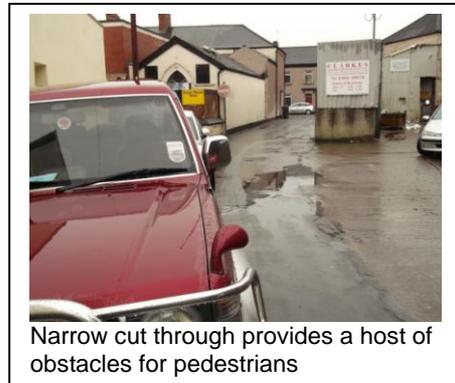
Walking down Chepstow Road into the heart of Maindee's retail centre, pedestrians are confronted by the Probert Place cut through coming in from Livingstone Place and Glebe Street. The cut through is an unadopted road and, as such, does not provide the usual safety features such as a designated footway, road markings and sufficient visibility. Individuals taking part in the Street Audit stated that you walked through the cut through 'at your own risk'. The cut through is in the heart of the centre of Maindee and so a large number of pedestrians cross this on a daily basis.

For partially sighted people and for elderly residents, the cut through is a significant threat to their safety. If the volume of traffic is to stay at the same level, there is a real need that the cut through be included in the list of maintained roads so that features such as footways and road marking can be introduced.

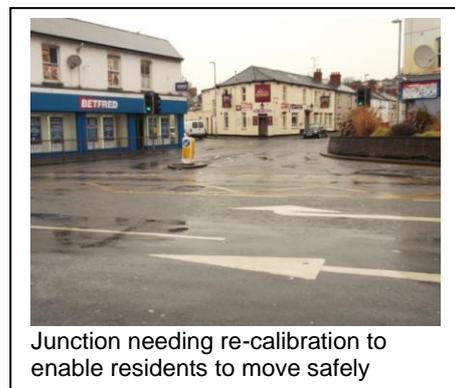
The current design of the Chepstow Road / Albert Avenue junction favours motor vehicles, with wide exit and entry carriage ways. It is also a reasonably complicated junction with a number of roads meeting at one point. For people walking around or through Maindee's retail centre, the junction provides a significant obstacle to overcome. There is a lack of designated crossing points and the wide carriageways mean that it feels precarious for local residents to cross where they need to. There is also a reasonably large poorly maintained flower bed on the corner of the junction.

The railings that are present prevent people from crossing the road at points convenient to them. In addition, the section of the footway in front of the BETFRED shop between Chepstow Road and Duckpool Road is well used by pedestrians. As a result, there is a need for wider footways and designated wide crossing points of the carriageway.

There is therefore a need to re-design this junction to ensure the safety and enjoyment of local people using the retail shops. Re-balancing the use of the space available (carriageways, footways and other public realm such as the flower bed) will significantly improve the appearance of the retail centre. This will have a significant impact on the economic regeneration of the area. In addition, designated crossing points in the correct locations will help people to move around the area.

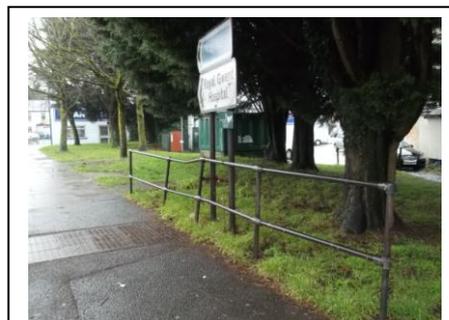
Turning from Chepstow Road onto Wharf Road, the Street Audit encountered a strip of green space that is poorly utilised. There is a short length of guard railing that serves no purpose and a series of trees with low hanging branches that significantly reduce the natural light for the space. Maindee has a limited amount of green space to offer to its residents and so it is important that each potential green space plot is maximised. If this strip of green space is re-designed, it would be more attractive for people to travel through and spend time in.

Poorly utilised green space plot on corner of Wharf Road

5	Green space plot on corner of Wharf Road and Chepstow Road	Lack of natural light due to tree branches	Liaising with Newport City Council to arrange tree pruning	Short term
5	Green space plot on corner of Wharf Road and Chepstow Road	Poor use of public realm space	Exploring ownership of land to then begin devising plans for a redesign of existing space	Medium term
6	Guardrails on Wharf Road and throughout	Overuse of Guardrails on Wharf road and on edge of car park on Chepstow road	Liaising with Newport City Council Transportation to undertake an audit of guard rails throughout the neighbourhood	Medium term

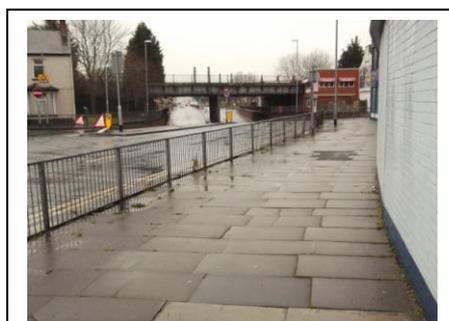
The Street Audit identified numerous locations in the Maindee neighbourhood where guardrails are in place. There is a significant length of guard rails on Wharf Road. Elsewhere, there is some guard rails in front of the Pay and Display car park set back from Chepstow road in Maindee's retail centre. This particular section of guard rails serves no purpose as it is located between the edge of the footway and the car park and so is currently serving as street clutter and should be removed.

Guard rails line the footway on Wharf Road

Guard rails can be a useful tool to provide additional safety to members of the public. The long stretches of guard rails on Wharf Road do not make improve on safety and deter people from crossing the road where they may want to. Large amounts of guard railing can bring the appearance down for a road.

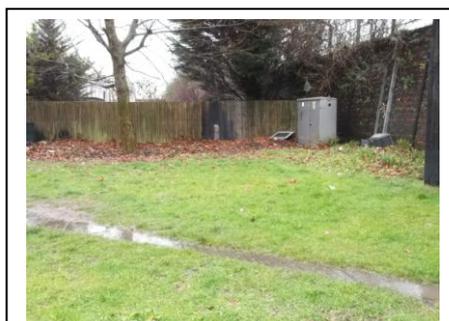
The green space plot on the corner of Wharf Road and Jeffrey Street is currently regularly littered with fly tipping. As previously stated, Maindee as a neighbourhood has a low amount of green spaces for residents. As a result, this green space offers real potential to be redeveloped into an additional space where people are happy to spend their time. Clarification with Newport City Council needs to initially take place on the ownership of the land and there are a number of electricity boxes on the plot which will restrict the use of the land. Nevertheless, the plot offers a local organisation with sufficient capacity the prospect of a shared community garden space for the future.

Green space plot that offers potential for renovation

neighbourhood			
7	Green space plot on the corner of Wharf Road and Jeffrey Street	Poor use of public realm space	Exploring ownership of land to then begin devising plans for a redesign of existing space	Medium term
8	Jubilee Gardens	Fencing surrounding gardens deters people from using them and worsens its appearance	Undertake consultation with local residents and schools to find out views on removal of fencing and research similar parks in the region to learn from their experience	Medium term
9	Walkway between Corporation Road and Riverside	Design of walkway needs softening	Explore ways to soften the existing design of the walkway to avoid desire lines eroding grassed sections	Medium term
10	Housing Development at Millennium Walk	Poor appearance of roadway and lack of footway for pedestrians	Liaise with Newport City Council and Housing Developers to assess final plans and their progress in achieving these to ensure that residents will be able to move safely through the development	Short term

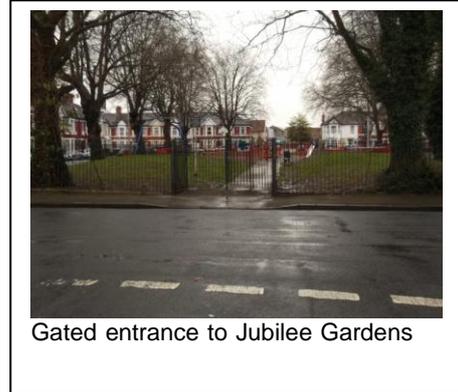
Jubilee Gardens is the only designated green space currently in Maindee. In this context, it provides local residents and families with a place where people can spend time and where local children can play. The outer edge of the park is lined by fencing and participants on the Street Audit commented that the park would be more used and would be more welcoming if the fencing was not there. It would probably prudent if some detailed consultation was undertaken on this with local residents and local schools. It would also make sense to visit similar spaces in the local region to learn from other peoples' experiences.

Gated entrance to Jubilee Gardens

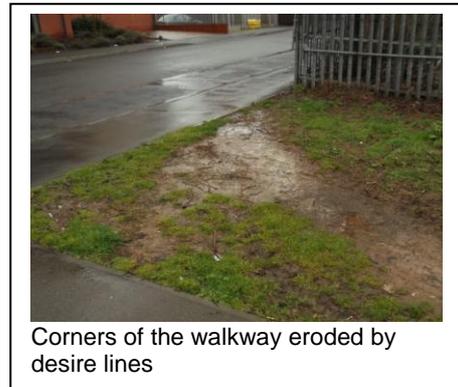
The Walkway between Corporation Road and the River Usk is a key access point to the local area. It enables Maindee residents to walk or cycle to the Riverside as an ideal route into the city centre. Street audit participants explained that wild flower seeds were planted last year in the verges to improve the appearance of the walkway. It would also be prudent to introduce curves in design at the beginning and end of the walkway to avoid desire lines eroding the grass verges. Curved lines would also improve the appearance of the walkway for pedestrians.

Corners of the walkway eroded by desire lines

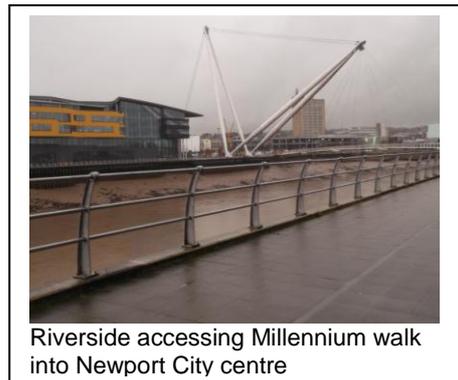
The Riverside Walk represents a key route for people walking or cycling between Maindee and the city centre. The walkway also offers residents with a pleasurable leisure walk alongside the River Usk. The walkway is modern and spacious but could benefit from some softer features such as signage that could encourage people to learn more about the local area.

Riverside accessing Millennium walk into Newport City centre

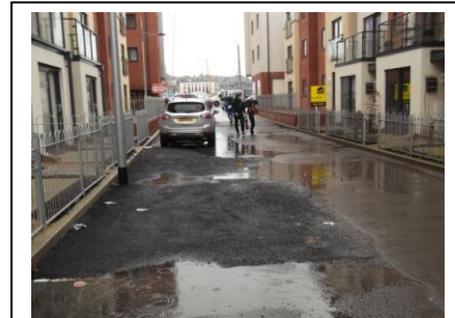
At the time of the Street Audit, a Housing Development was being completed on Millennium Walk. Due to the heavy rain that fell on the day, it was apparent that the road surfaces were of poor quality, causing the pooling of water. In addition, it seemed that there was no designated footway for people to walk through. Millennium Walk provides a key walking route between Maindee and the city centre and so, as such, this section is critically important. The problems identified may have been caused as the development had not been finished at the time. It will be necessary to consult with the Housing Developer and Newport City Council to clarify on these issues.

No footway and poor surfaces within the housing development

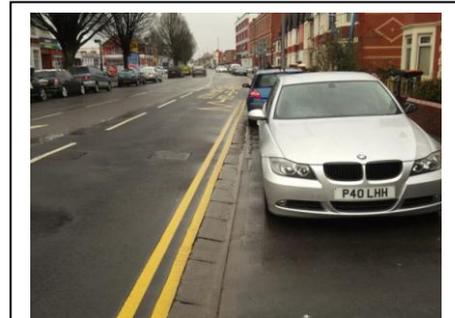
Throughout the Street Audit, participants identified locations where double yellow lines were not being enforced. As a result, it seems that there is a general culture for people to park on the double yellow lines knowing that they will not be penalised. On Corporation Road the Street Audit identified a large number of cars parked on double yellow lines, but also parked on pavements next to double yellow lines. This practise makes Maindee's local streets more unsafe for its residents. The parking on pavements provides significant obstruction for people with mobility issues, sight impairments or buggies with children.

Pavement parking and double yellow lines

11	Double yellow line parking in Corporation Road and throughout neighbourhood	Double yellow lines are not being enforced	Liaise with Newport City Council to find out about enforcement resources in the city. Explore working with the team to deliver a short-term campaign in Maindee to enforce people to not park on double yellow lines	Short term
